## MANAGING ASBESTOS

Asbestos is known to exist in a large number of buildings used by Scouting and can cause unnecessary worry or expense by its presence. This guidance aims to clarify and standardise the approach in the way Scouting manages asbestos and Asbestos Containing Materials (ACMs). In Scouting we have a moral and legal duty to manage the ACMs in our buildings and to protect all our Members, visitors and users from exposure.

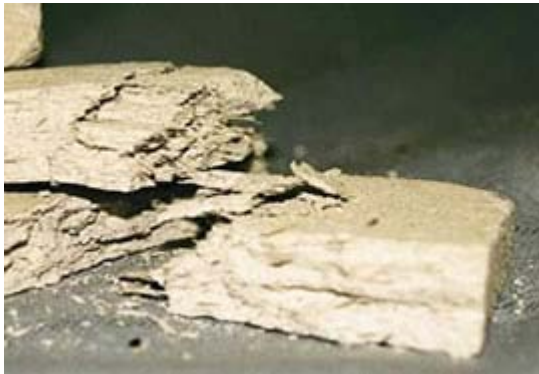
AIB Debris

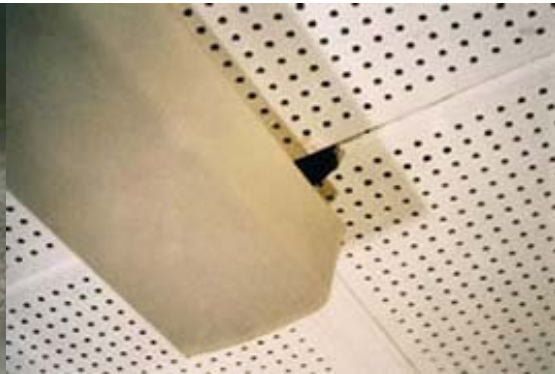
AIB perforated ceiling boards

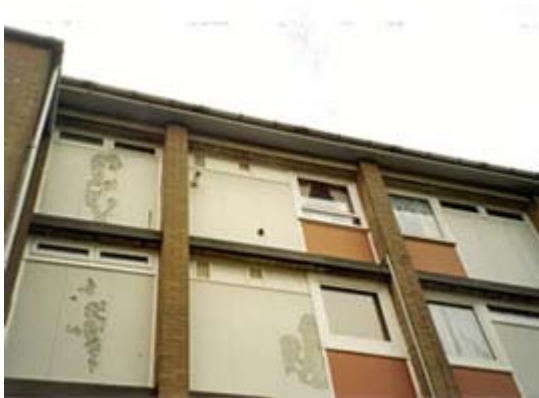
AIB external wall panels

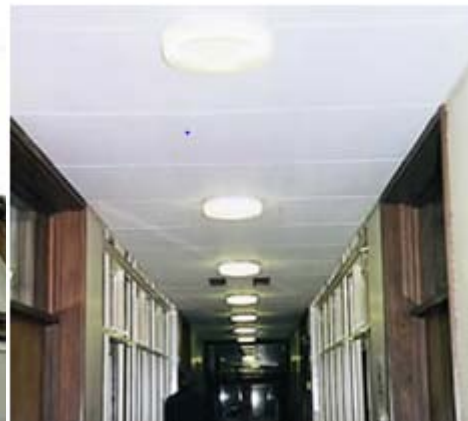
AIB Suspended Ceiling

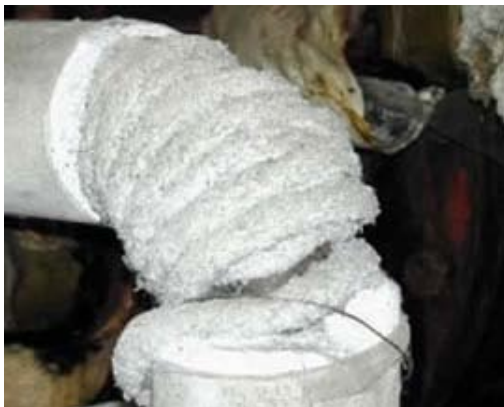
Asbestos Rope and Asbestos Insulation

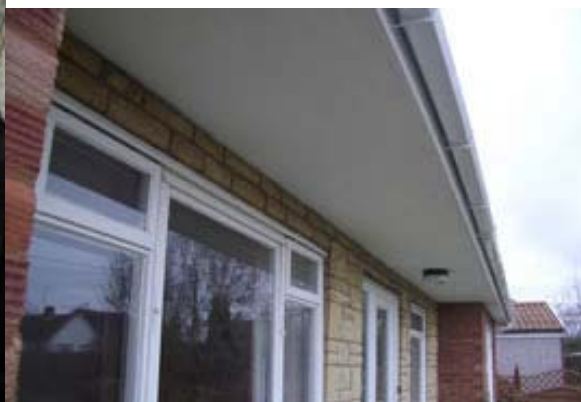
AIB External Soffit

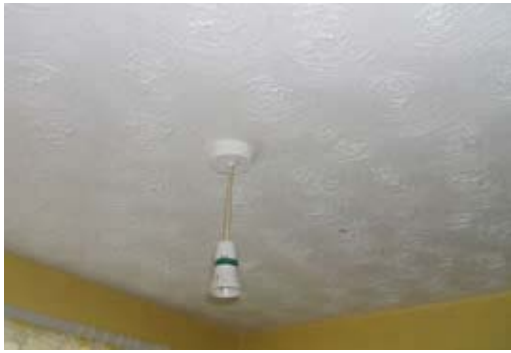
Asbestos Textured Coating (Artex) Ceiling

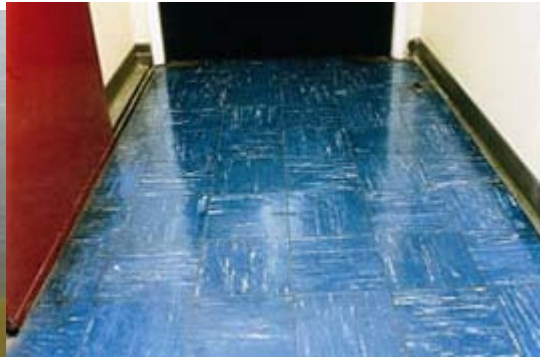
Asbestos Vinyl Floor Tiles

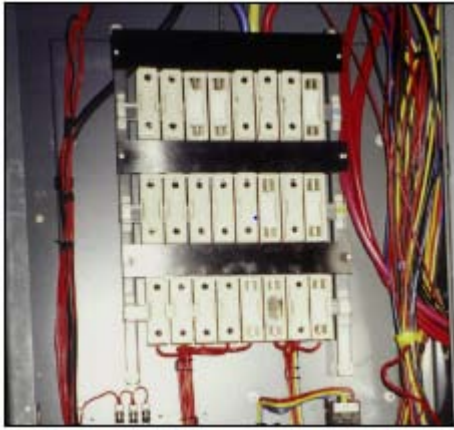
Asbestos Textile within Fuses

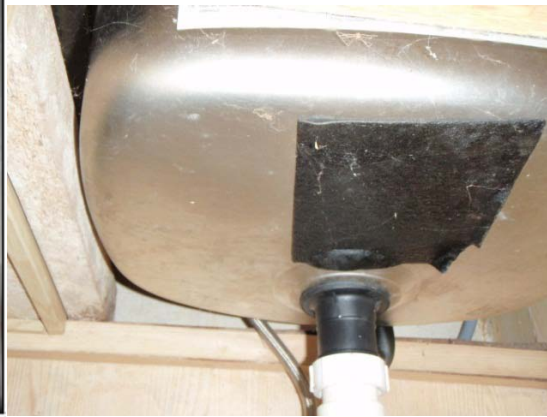
Asbestos Bitumastic Dampening Pad on Steel Sink

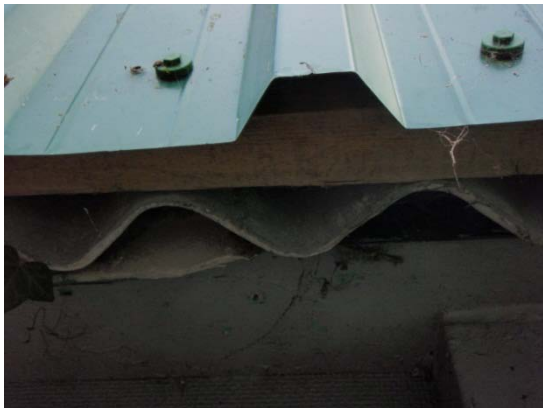
Asbestos Cement behind metal profile

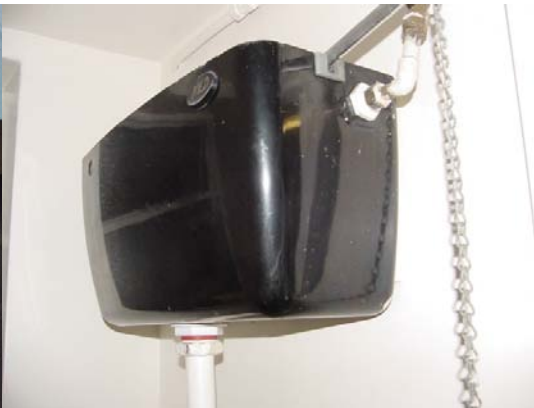
Asbestos Resin Reinforced Toilet Cistern

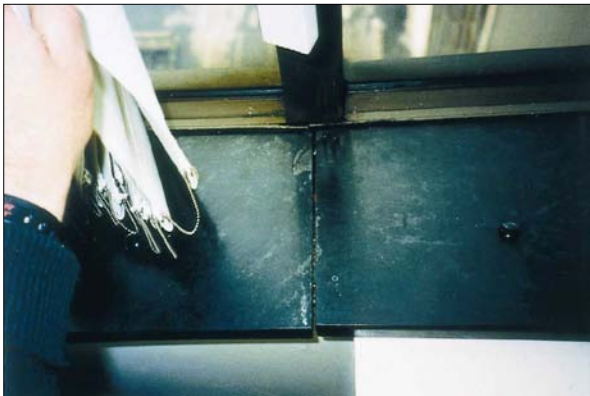
Asbestos Window Cill
